Container Supervision Report

Yiwu port

2013.11.29

LC0020131108

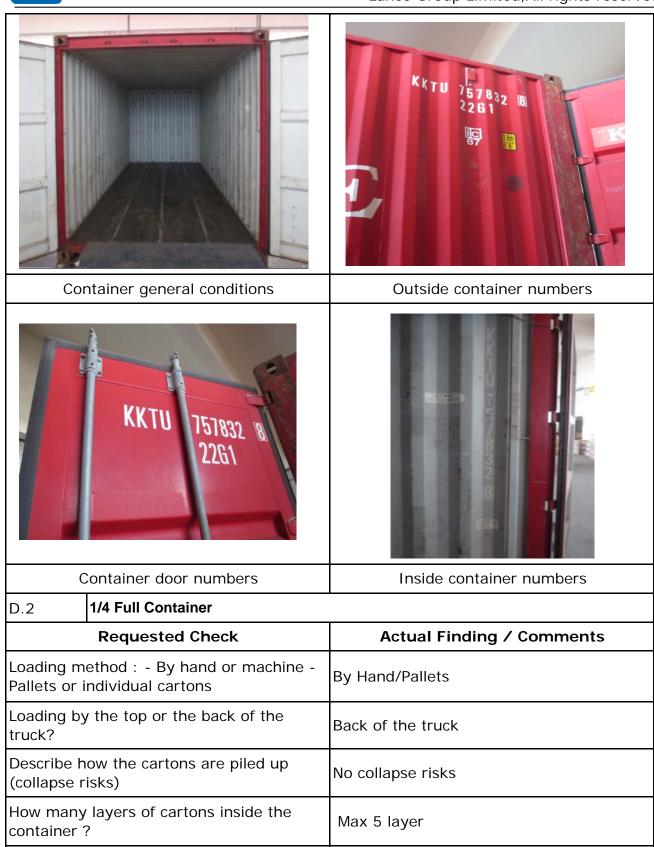
D.LOADING PROCESS			
D.1	Empty Container		
Requested Check		Actual Finding / Comments	
- Water - Rust hole - Dust - Grease - General	general conditions: es cleanliness need dryer	Overall container condition is good and free from: - Water - Rust holes - Dust - Grease - General cleanliness - Dry weather, no need dryer	
Container	seal numbers	UBK27705	
Inside con	tainer numbers	KKTU 75783222G1	
Outside container numbers		KKTU 75783222G1	
Pictures As bellow

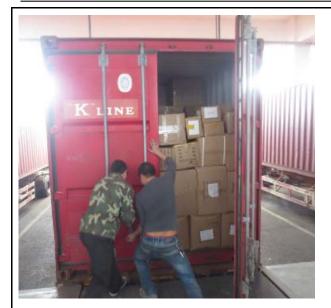
Closing the Door

D.4	Container closing	
	Requested Check	Actual Finding / Comments
Are seals t	emporary or definitive?	Definitive
